**NASA
Technical
Paper
2884**

**Cyclic Loads Tests of
Carbon Involute Solid
Rocket Motor Outer
Boot Ring Segments**

Rafiq Ahmed
*George C. Marshall Space Flight Center
Marshall Space Flight Center, Alabama*

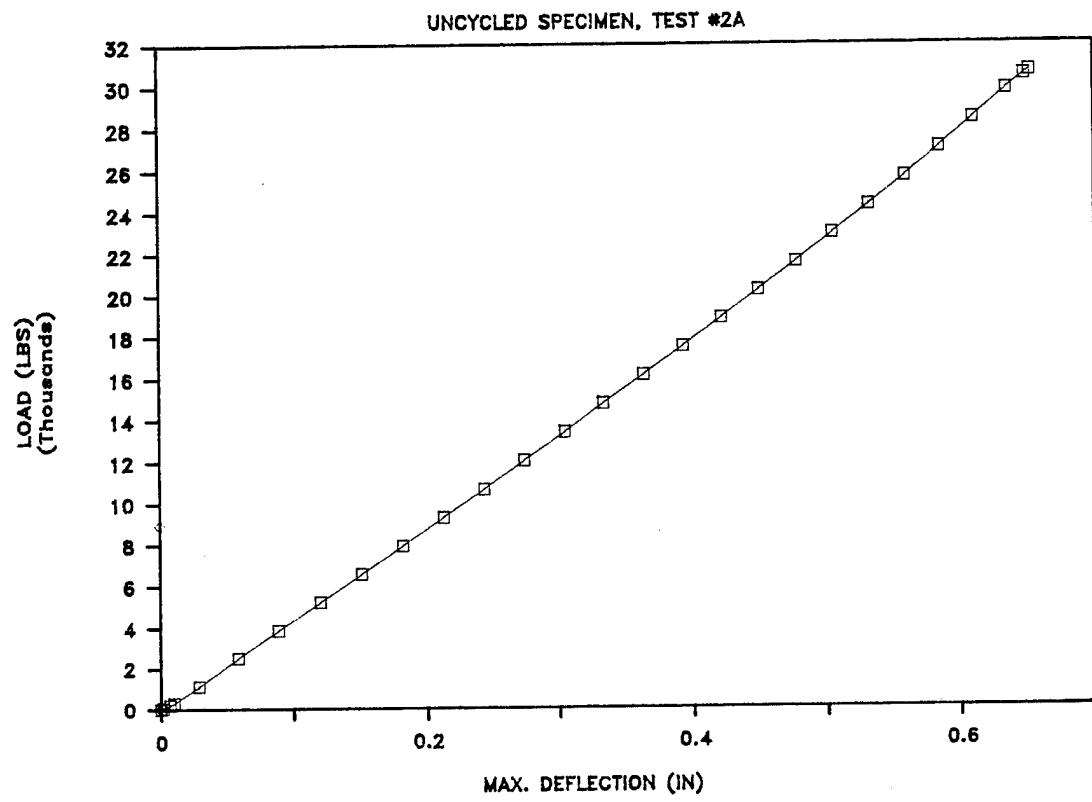
Typically, most of the load versus deflection and load versus strain curves were linear in the elastic range with a decrease in slope as higher loads were reached. However, an interesting phenomenon occurred in Test No. 2A, where an increase in slope of both the load versus deflection and load versus strain curves was noted as the load approached ultimate. These plots also showed that the specimen stiffness was lower in the linear range for Test No. 2A than for Test No. 2. This was attributed to matrix degradation in the CCP that resulted from the first loading of 34,000 lb (which was at or near imminent failure), while the increase in stiffness at the higher load levels of Test No. 2A was attributed to microcracking of the fibers (this most likely happened in Test No. 2). The fibers sustain most of the load at these higher load levels. It is interesting to note that none of the cyclic loadings produced a similar effect in the material, since they were of insufficient peak load.

Figure 8. OBR cyclic loads test, uncycled specimen, Test No. 2A.

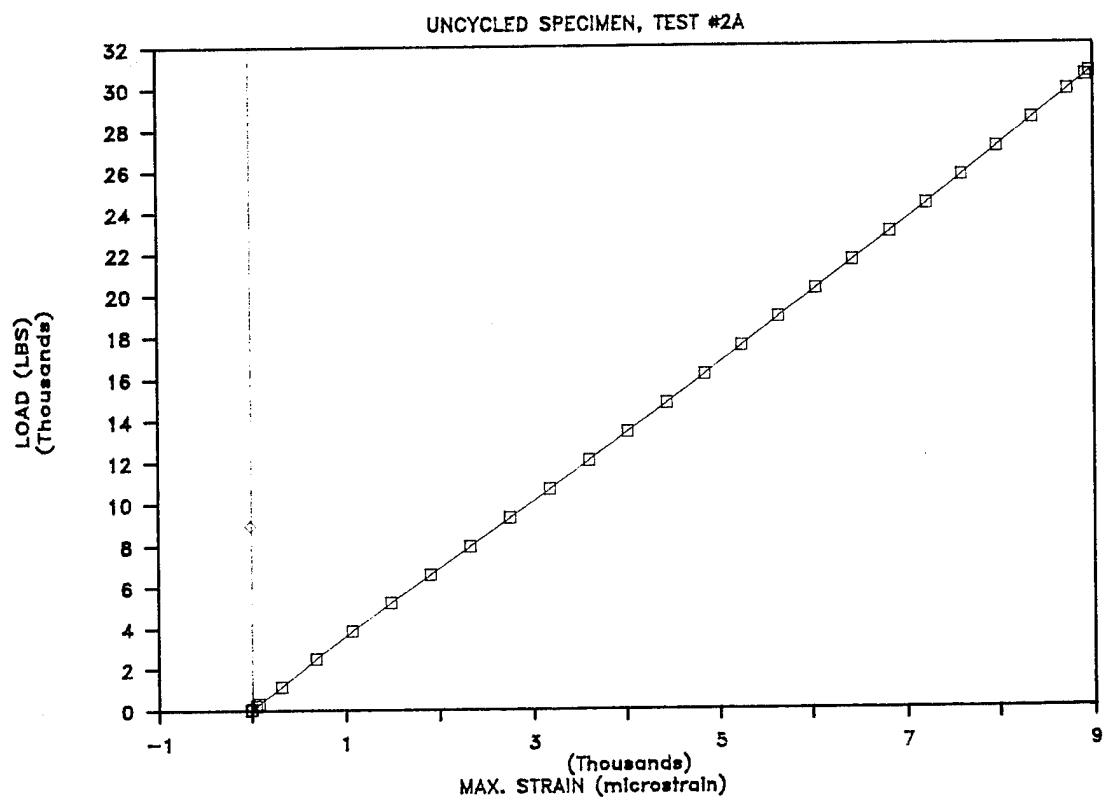
The agreement between the elastic moduli of the different samples is quite good; the scatter between the lowest and the highest moduli (not including Test No. 2A) is only 12 percent. As noted previously, Test No. 2A's modulus is low due to degradation of the part from Test No. 2. The increase in Test No. 2A's plastic modulus is clearly seen.

Figure 16. OBR cyclic loads test, uncycled specimen, Test No. 2A.
